Report on  
Geotechnical Investigation

Officer South Retarding Basins  
Officer South

Prepared for  
Jacobs Group (Australia) Pty Ltd

Project: 217545.00  
15 May 2023

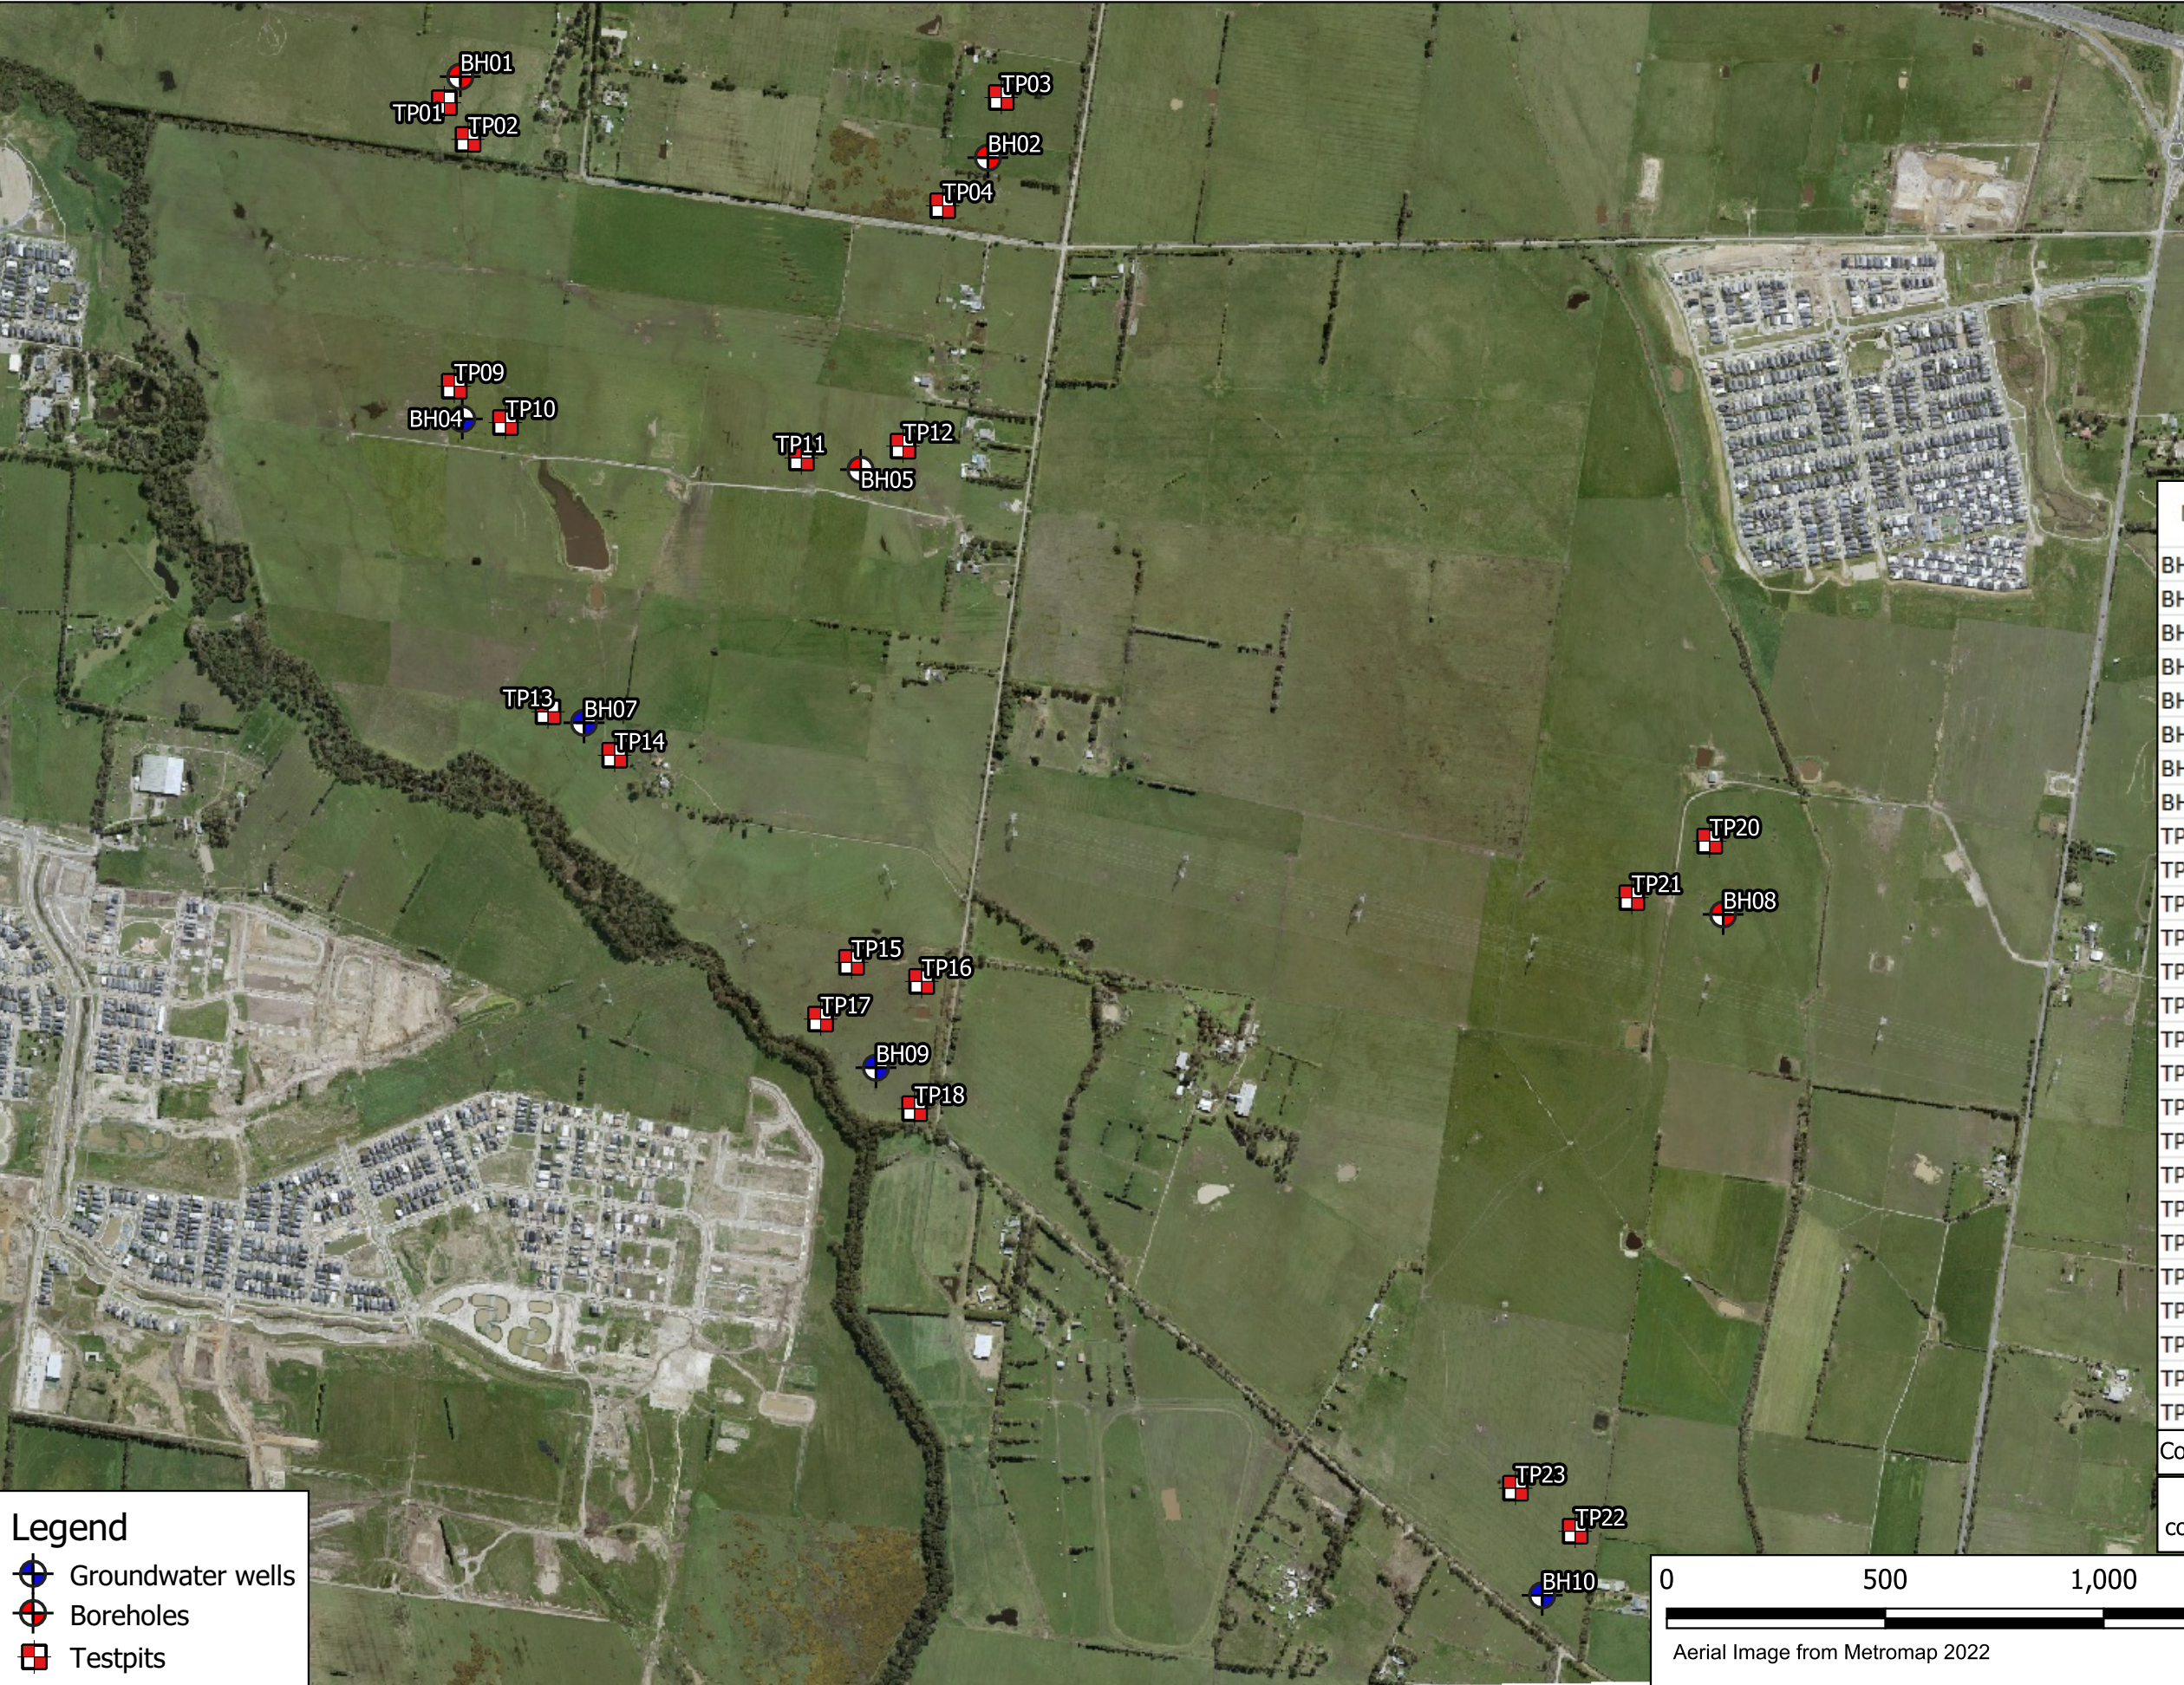
Drawings

Name	Easting	Northing	Elevation (m AHD)
BH01	358693.4	5784144	32.6
BH02	359901.2	5783959	28.3
BH04	358697.7	5783360	29.8
BH05	359609.3	5783244	26.8
BH07	358976.6	5782665	26.1
BH08	361584.6	5782226	17.8
BH09	359645	5781875	21.5
BH10	361170.3	5780667	12.4
TP01	358656.8	5784084	32.5
TP02	358711	5784000	31.9
TP03	359931.8	5784096	29.0
TP04	359797.8	5783848	28.7
TP09	358679.4	5783435	30.4
TP10	358796.7	5783352	29.5
TP11	359474.1	5783271	27.6
TP12	359706.9	5783298	26.8
TP13	358894	5782690	26.4
TP14	359046.7	5782590	25.9
TP15	359589	5782116	22.2
TP16	359749.5	5782073	21.6
TP17	359518.2	5781986	22.0
TP18	359733.4	5781781	21.1
TP20	361553.7	5782394	17.9
TP21	361375.5	5782264	18.1
TP22	361245.8	5780814	13.1
TP23	361109.1	5780912	13.4

Coordinates are relative to MGA94 zone 55H

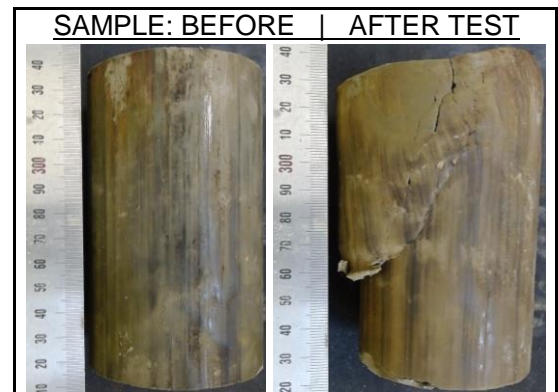
**UNDRAINED SHEAR STRENGTH** **Stage 1**  
 $C_u$  (kPa) **106**

Dry density ( $t/m^3$ ):	1.70
Sample Length (mm):	126
Sample Diameter (mm):	64
Specific Gravity ( $t/m^3$ ):	2.65 (Assumed)
Initial Degree of Saturation (%):	91

1. Membrane corrections were applied.
2. Mode of Failure: Shear 65°

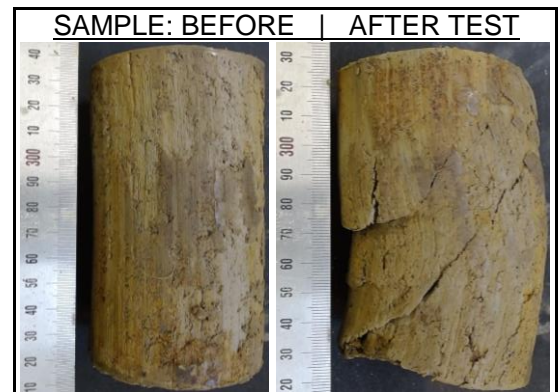
**UNDRAINED SHEAR STRENGTH** **Stage 1**  
 **$C_u$  (kPa)** **87**

Dry density ( $t/m^3$ ): 1.65  
Sample Length (mm): 124  
Sample Diameter (mm): 63  
Specific Gravity ( $t/m^3$ ): 2.65 (Assumed)  
Initial Degree of Saturation (%): 89

1. Membrane corrections were applied.
2. Mode of Failure: Shear 60°
